FIELD STUDY OF INSULATED RAIL JOINT DEGRADATION ON VÄSTKUSTBANAN

Field study

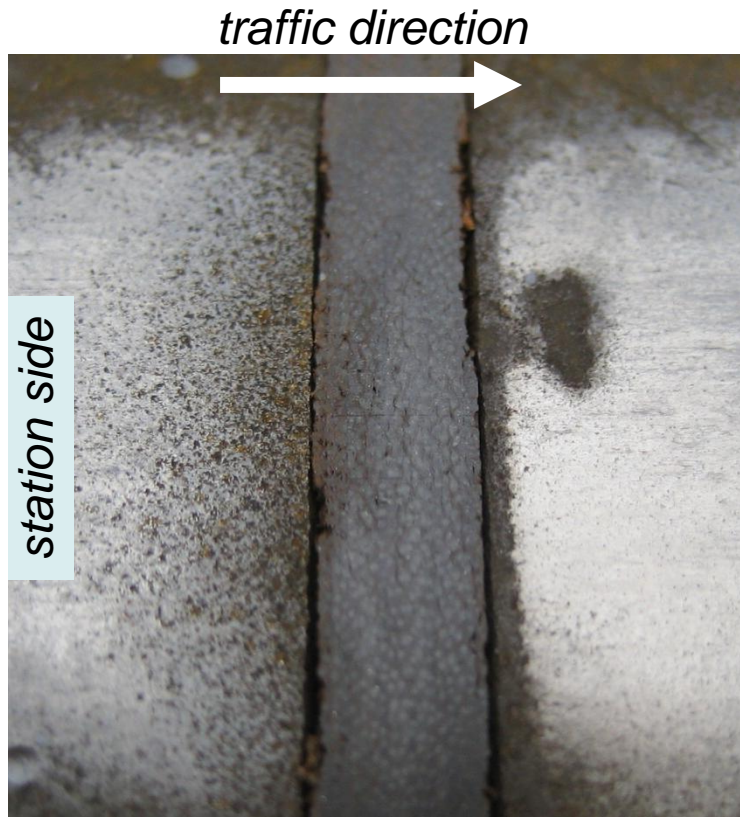
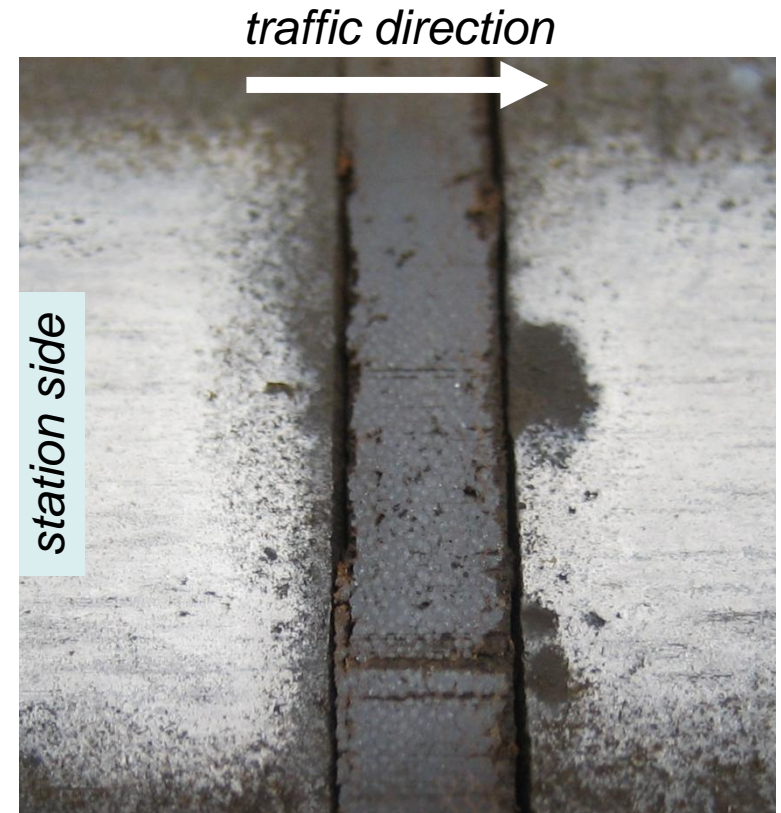
- All joints showed similar damage patterns
- Wear-like pattern appearing quickly on the station side
- Failure-like (material detachment) on the other side of some joints

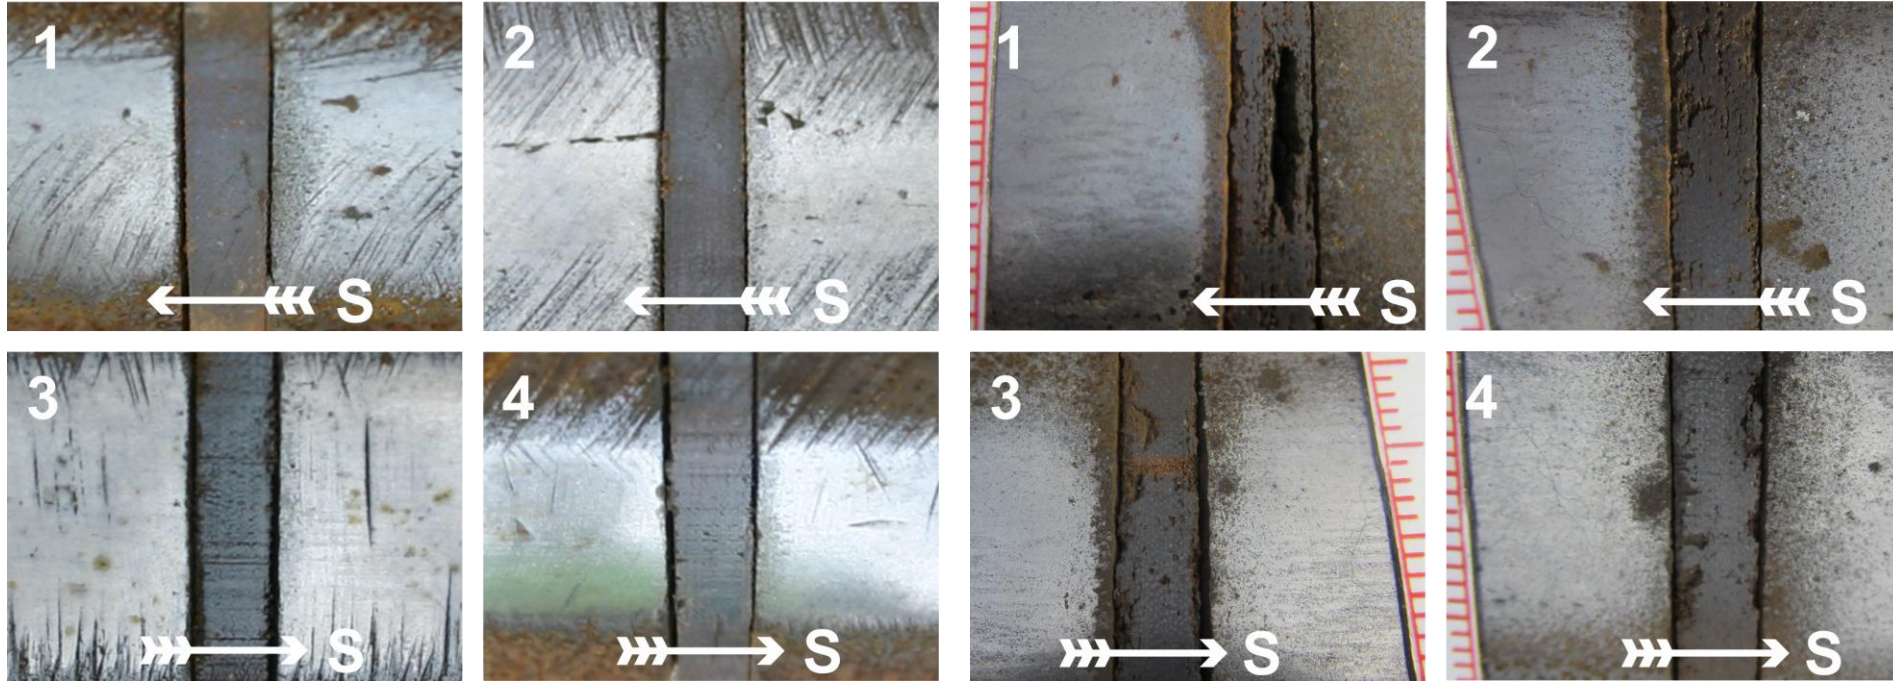
Typical damage pattern occurring on the station side. S indicates station side and arrow main travelling direction

- Vertical impact is not the dominating cause of damage here
- Compressive longitudinal force lifts up the rail on the station side (while train is accelerating and braking at the station)
- “Cavity-like” damage was found after a half a year on two of the joints (2 and 4) on the side of the joint away from the station

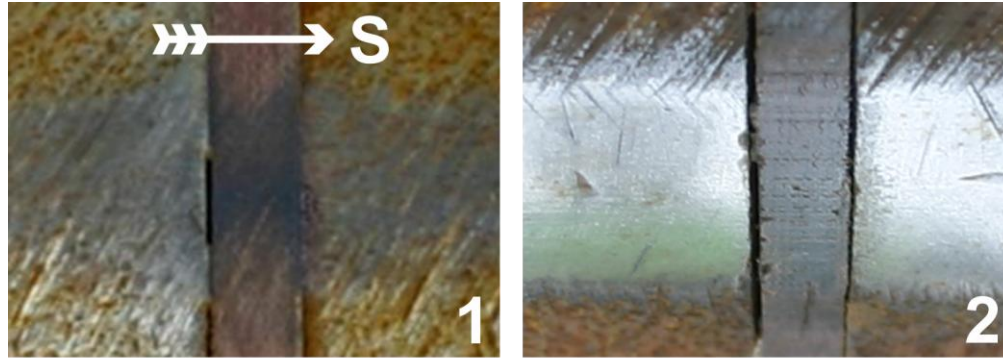
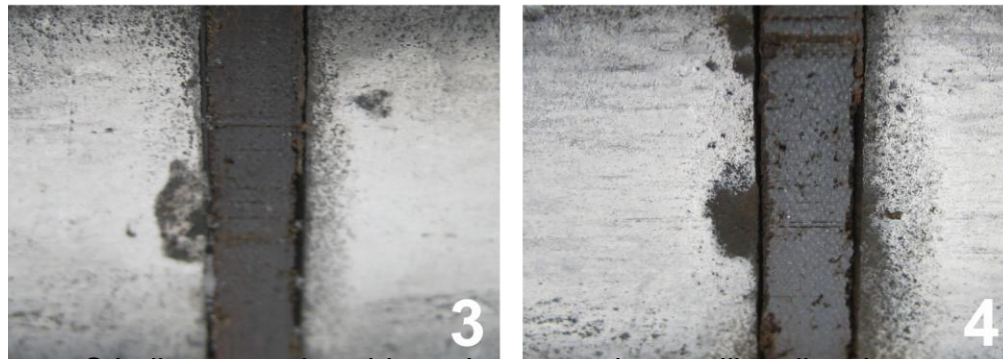
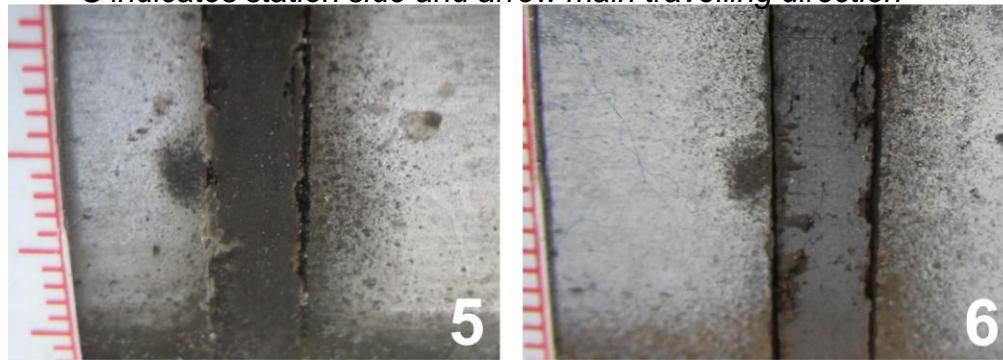
Damage evolution of the insulated joint 4

S indicates station side and arrow main travelling direction

- Photographs taken show the degradation pattern of the joint during three years

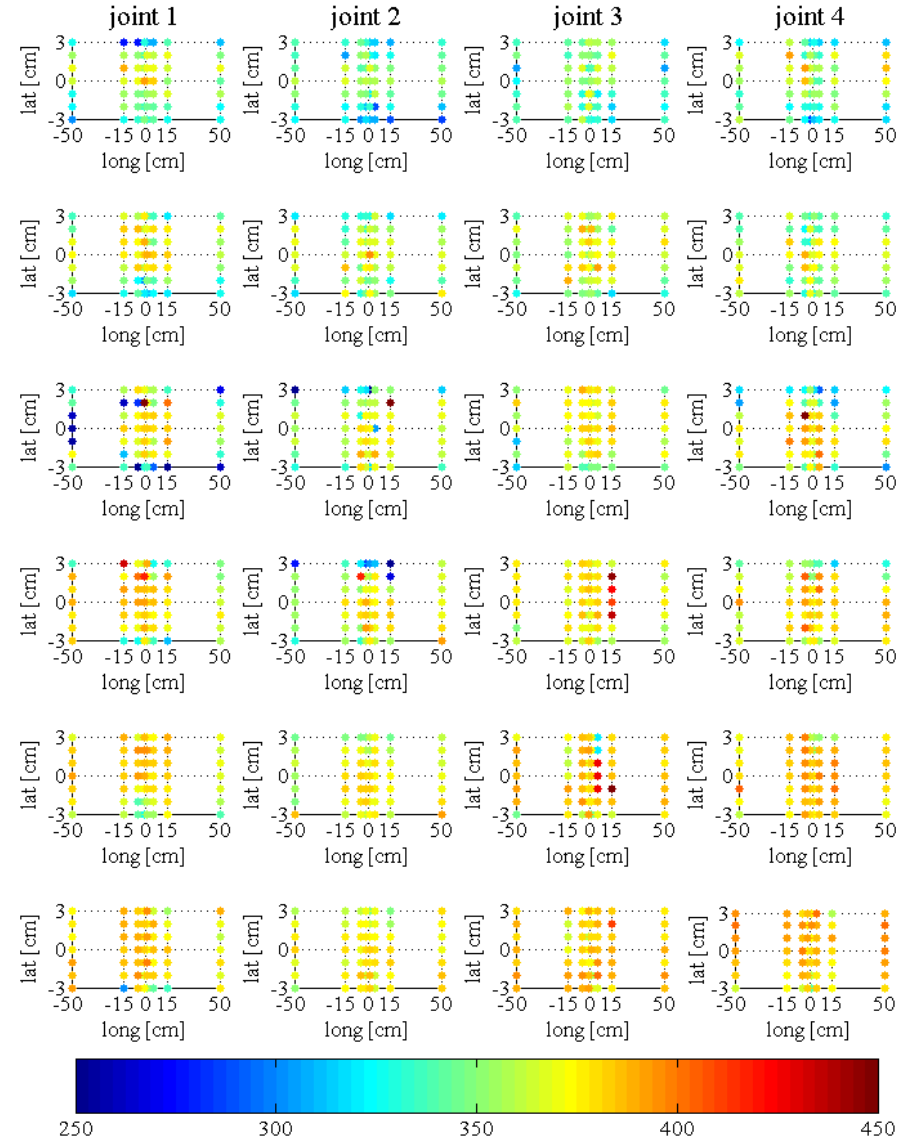
- Performed at the rail head surface close to the joint
- The joints manufactured from head hardened steel
- Hardness seems to have stabilized at the end of the observation period

Hardness averaged for the three lines closest to the rail head centre ("c", "d" and "e") for all joints at all six measurements

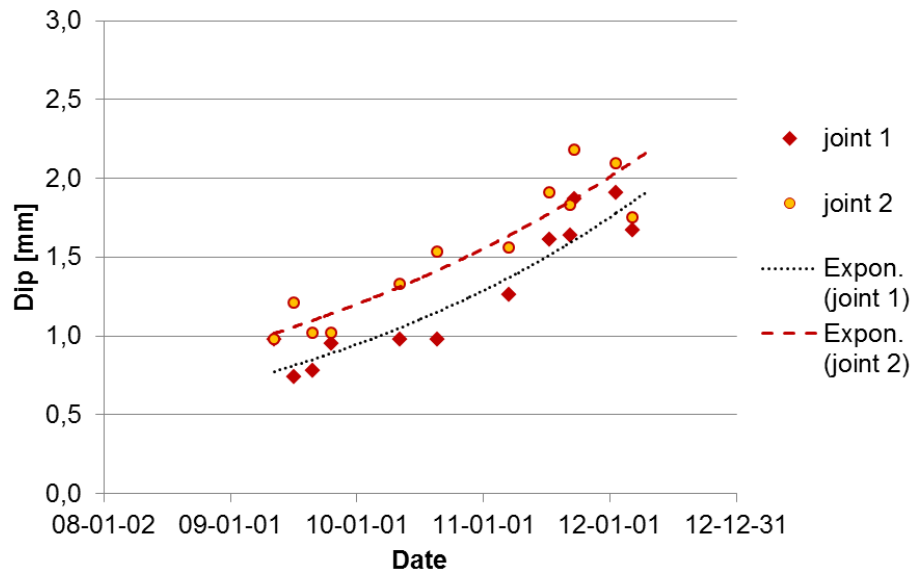
Vertical geometry degradation of insulated rail joints 1 and 2

- Track geometry degradation increases the loading, which in turn increases the deterioration
- Geometry degradation is not a linear phenomenon
