Lost in the Shopping Centre?

A Study of Wayfinding Design in a Large Shopping Centre from the 2010's

Universal Architecture in the Designer's eye, HT 2016

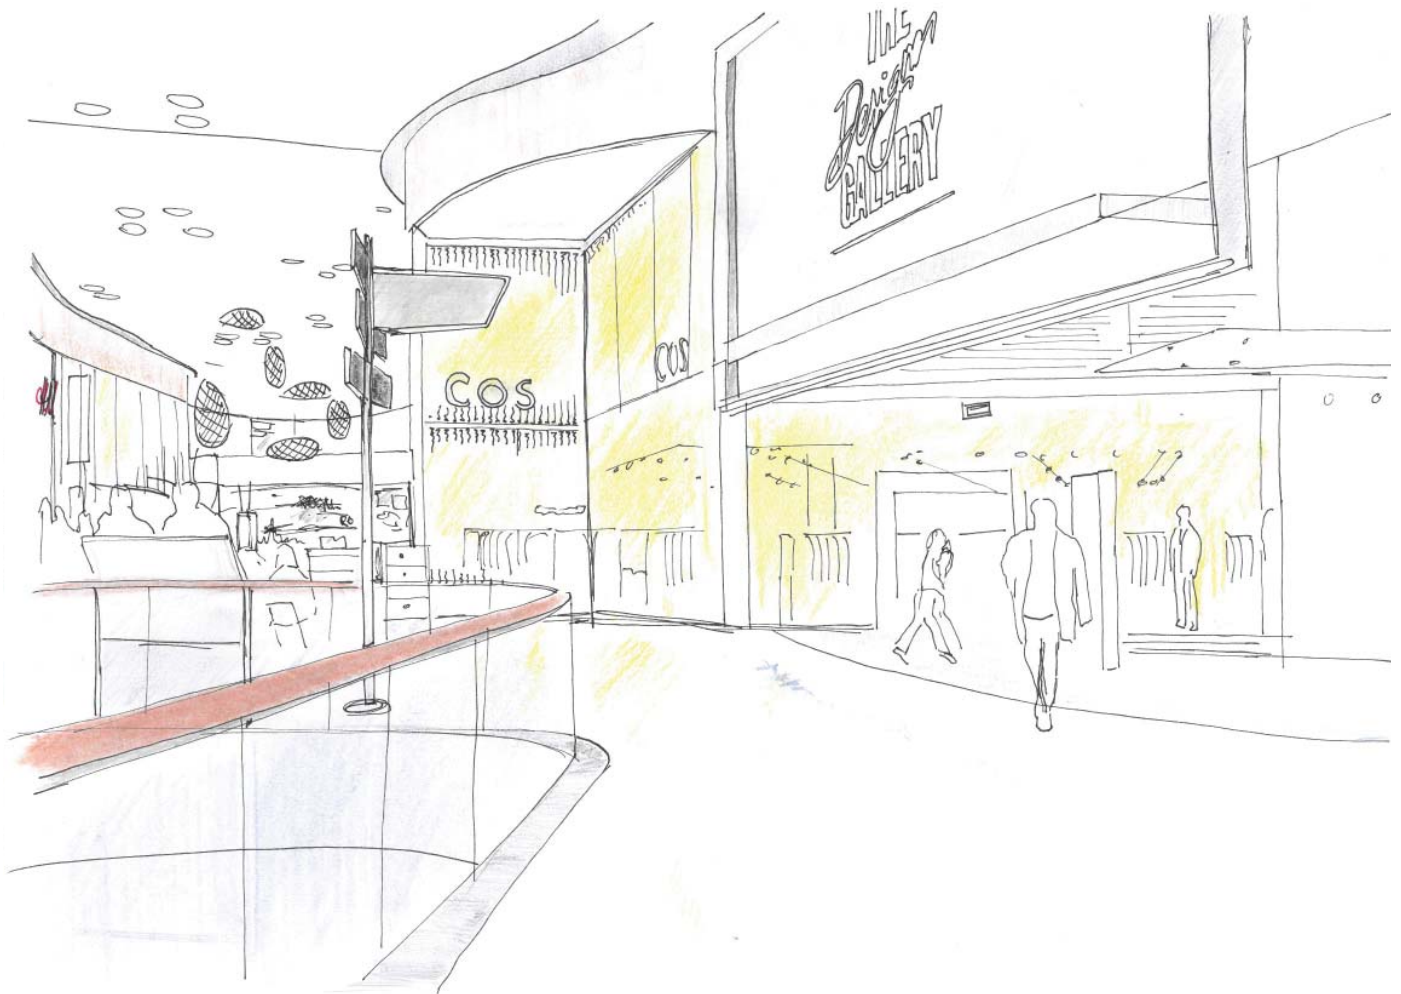
Fig 1.5 Entrance to Designer Gallery
transition point and node

There were three identified districts at the route: the Design Gallery, the Dining Plaza and a Service District. The districts were functional grouping: collections of high fashion brands, restaurants and service functions. The Design Gallery was most distinct as it was spatially and materially separate from the main triangular loop and had its own specific name that was emphasised by large signs at the entrance (fig 1.5). The district entrance was an example of a transition point where the sign and material change (the edge) marked the transition from one scale and circulation pattern to another. (Arthur and Passini, 1992, p.131). The Dining plaza was part of the circulatory loop but was distinguished by open restaurant facades with seating outside and a ceiling with hanging plastic rods that changed colour over time.

The second node was the junction between the Design Gallery and the triangular loop. It was less physically strong than its corner counterparts as it was not spatially defined by a wider shape. It was, however, distinguished by its proximity to the distinct designer gallery entrance. (fig. 1.5).

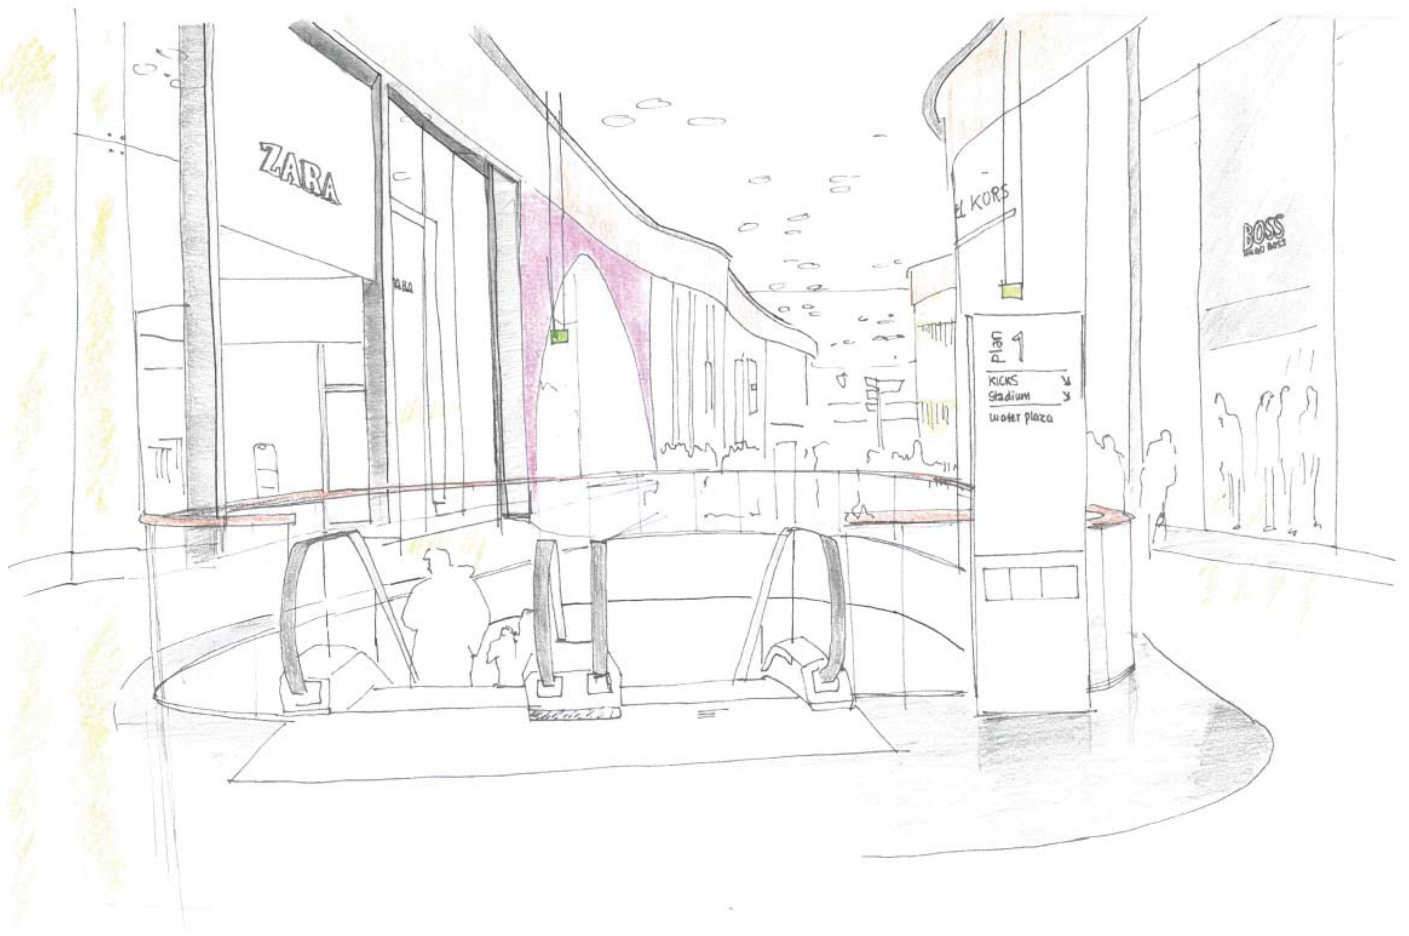
Fig 1.7 Vertical connection at the avenue

The vertical connections, escalators and lifts: were not considered to be nodes in this study as they were very unarticulated. The escalators were spatially disconnected from the primary nodes (see fig 1.7) and had no vertical or spatial markers which made them easy to pass. The lifts were placed in the service district and were not visible from the main paths. This made the transition between floors confusing and disorienting.

The lack of identity was apparent between floors as well. The unarticulated escalators provided no transition point between the floors (fig. 1.7) and there was no distinction between the upper or lower circulatory system.
