-Road Profiles, Friction and Safety

johan.granlund@sweco.se, Senior Consultant

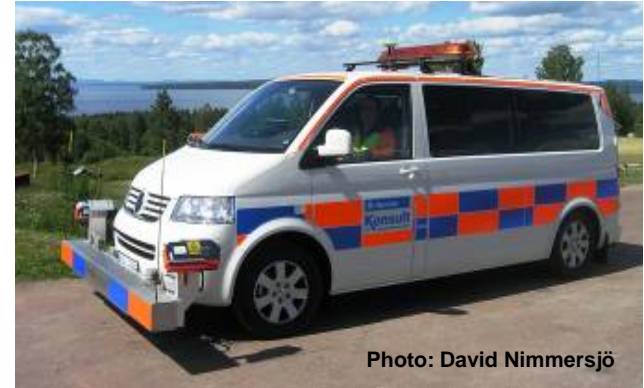
Road condition surveying with laser/inertial Profilographs

Photos in full High-Definition of road environment and road surface (optional).

Alignment, roughness and condition.

Laser/inertial technology.

Accuracy: Fractions of mm.

Profilometers in commercial operation since 25 years on roads and airfields.

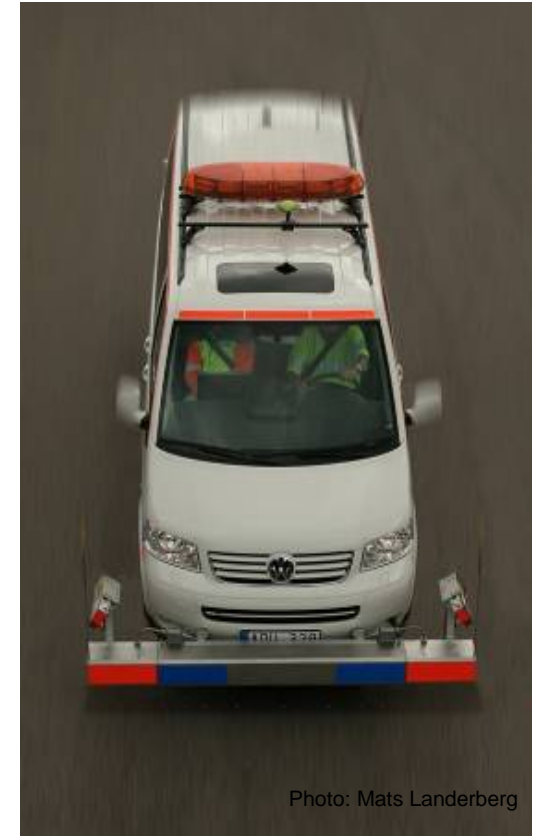
Measurement at normal traffic speed:

- Travelled distance of the left non-powered wheel.
- Distance to road surface is measured in 17 lateral positions, 16 000 times per second, about 1 sample/mm.

- Movements of the rut bar.

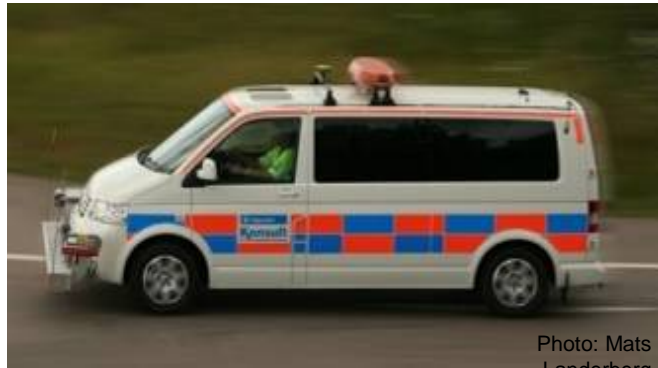
By combining data from lasers, inertial unit, etc., an accurate model of the lane “topographical shape” is created.

At 72 km/h, the system measures 3.2 m width x 20 m lane length every second.

400 000 samples/sec => 8 000 filtered values stored.

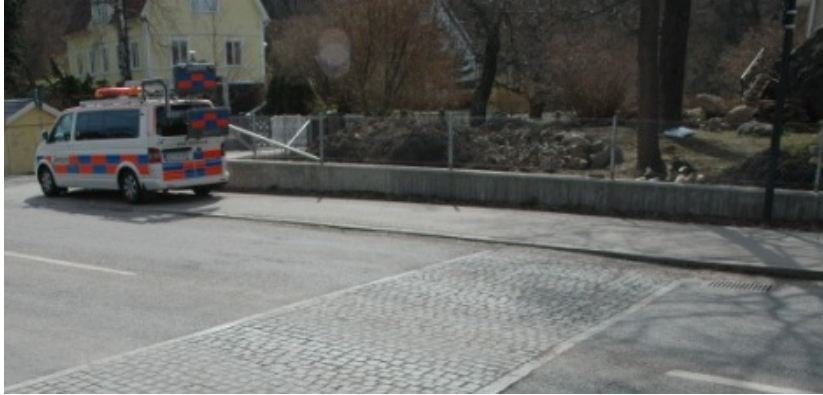
Road profiling with **sweeping laser**

Alignment, roughness and condition.

Laser/inertial technology.

Photos in full HD.

Retroreflection.

Height & Width Clearance.

Pavement and roadside depicted in **full 3D**.

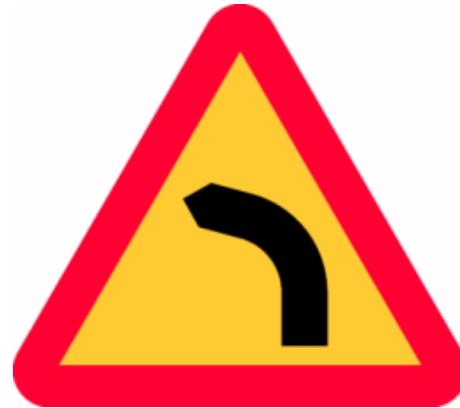
5 times as many fatal single-vehicle crashes in outer-curves

than in inner-curves

Two key factors are:

- Insufficient banking => high lateral (side) forces.
- Often poor drainage at entrance/exit of banked curves.

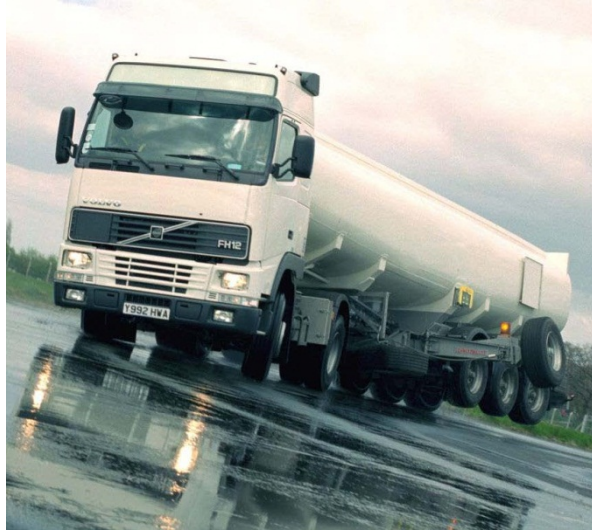
Heavy vehicles are very sensitive to side forces

The crash type were most truck drivers are injured is the **rollover**.

Higher C.o.G. makes the vehicle prone to improperly banked outercurves

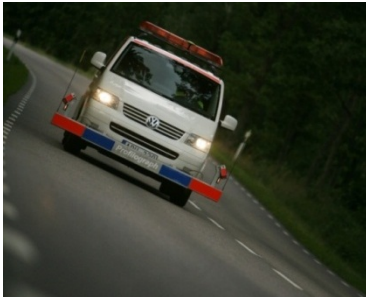
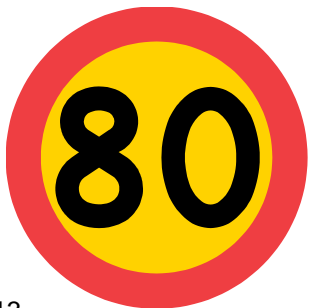
Side friction demand:

$$f_s \approx \frac{v^2}{R * g} - \tan(\alpha)$$

Measured data for the radius of curvature R and superelevation $\tan(\alpha)$ are taken from our laser/inertial Profilograph.

Reference speed converted into SI-unit [m/s].

Ex. 80 km/h = 80 / 3.6 = 22 m/s

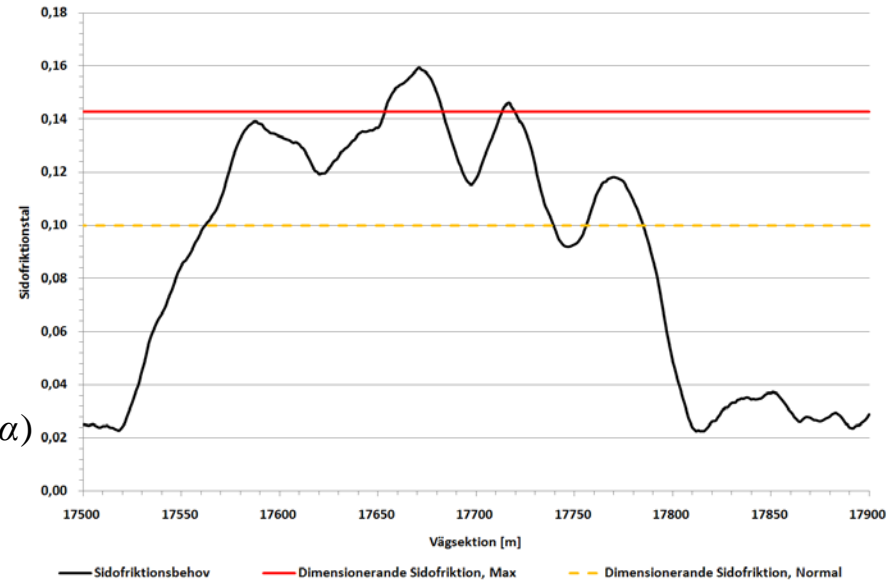
Analysis of the improperly banked “Curve of Death”

$$f_s \approx \frac{v^2}{R * g} - \tan(\alpha)$$

The improperly banked curve on road E12 have 5 crashes in 45 meter.

The need for side friction in the “Curve of Death” exceeds the friction supply value in the road design code VGU.

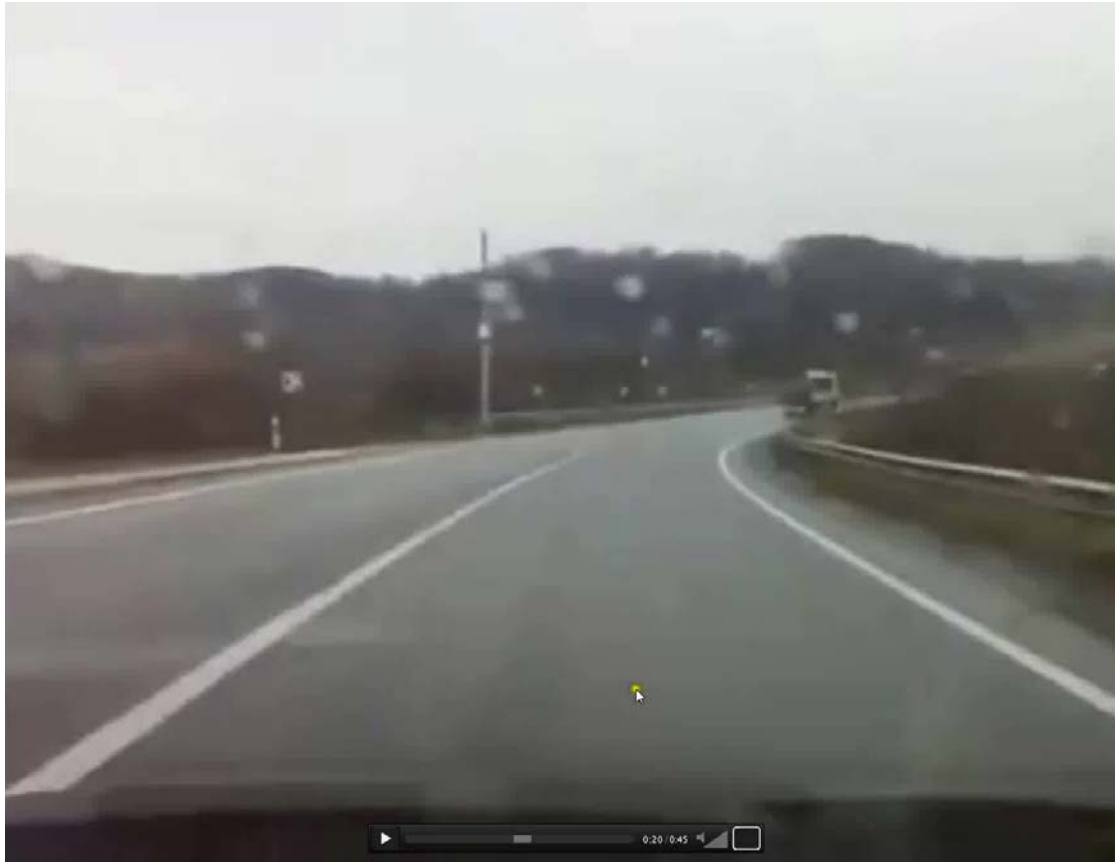
Hydroplaning at banked outer curve

Oncoming Heavy Goods Vehicle brakes at curve entrance.
The waterfilm is very thick just there, due to improperly designed Drainage Gradient (DG).

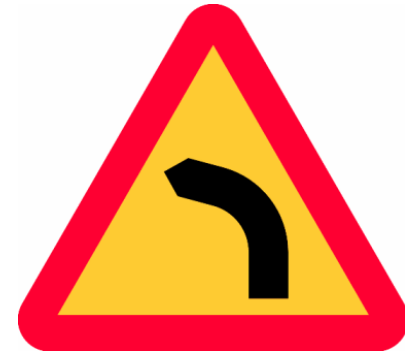
$$DG = \sqrt{i^2 + E^2}$$

Risk for low DG only where **E** change direction, pass 0 % (zero) and changes sign +/-.

This occur at **entrance and exit of banked outercurves***.

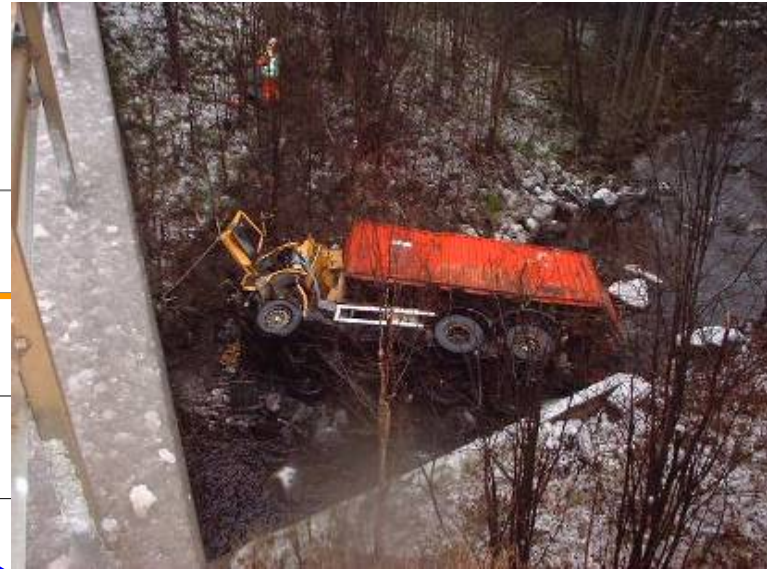
Bridge in Viksjö at 30 050 and 30 021 m

Too low Drainage Gradient at the Canyon of Death

Exit from
outer-curve.

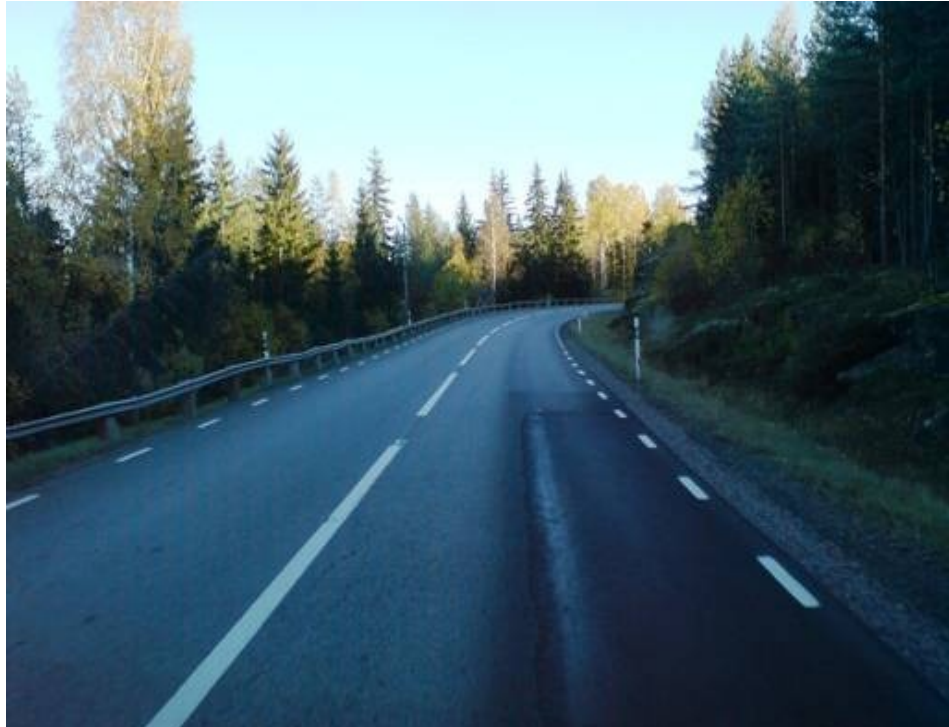
Entrance to sharp bend.

The edge was patched with a "fat" asphalt mix.

NOTE: Sealed longitudinal joint.

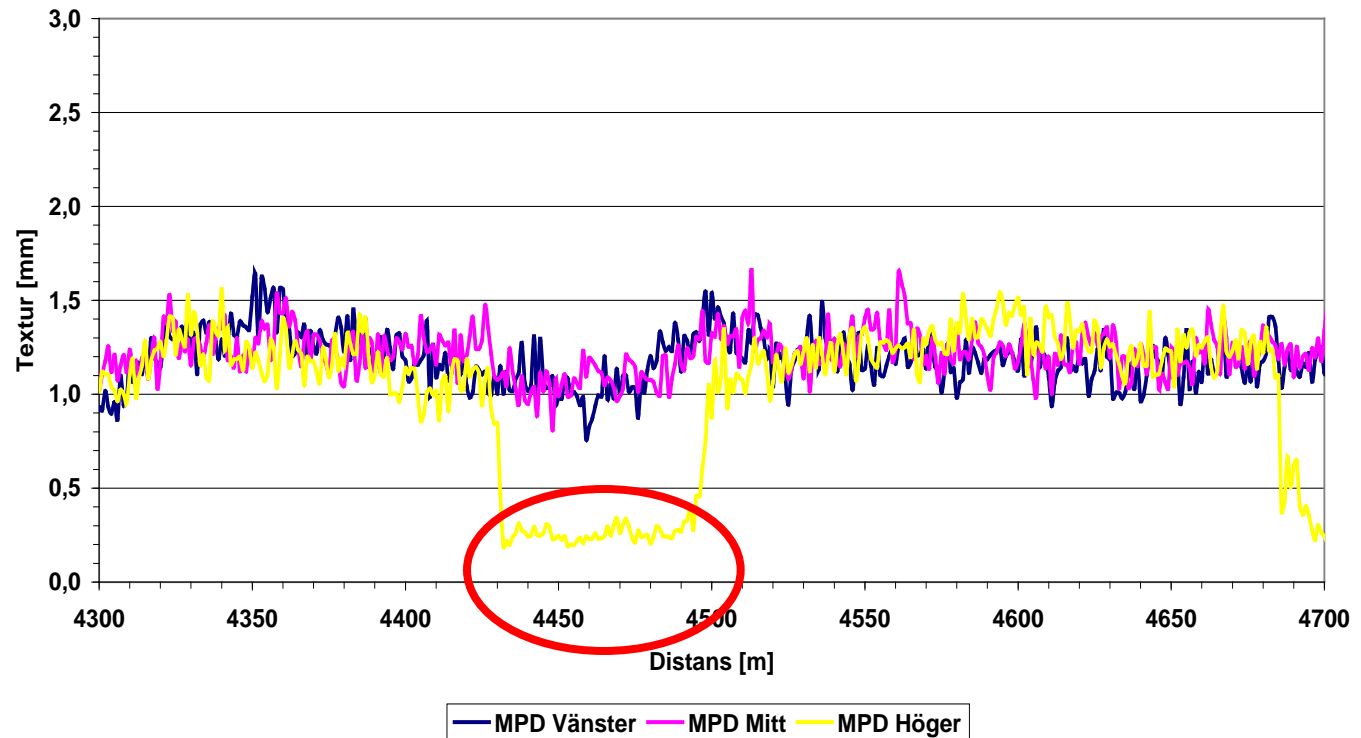
Vägbanans makrotextur (ytskrovlighet)
Avgörande för våtfriktion samt hastighetsberoende del av friktionen
Olycksplats 10/9 vid distans ca 4680 m (- upp till ca 200 m)

66 m long "fat"
(bitumen-rich)
patch in the right
hand wheelpath.

Macrotexture far
below threshold
value "Minimum
0.6 mm."

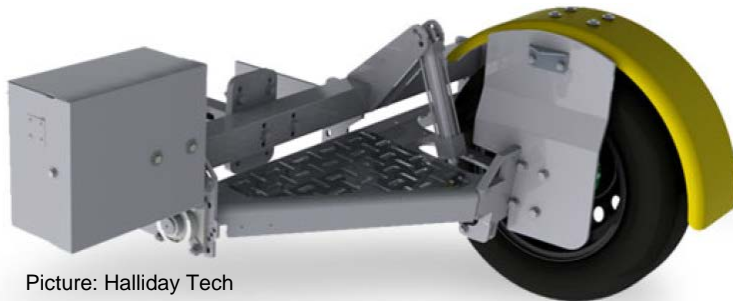
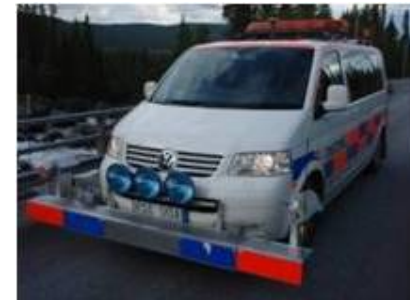
International Friction Index (IFI) clearly shows how much friction decrease with increased speed.

IFI is defined in standard ASTM E1960 (SRI in EN 13036-2). IFI & SRI are calculated from data on friction at any speed, together with data on texture from laser scanning.

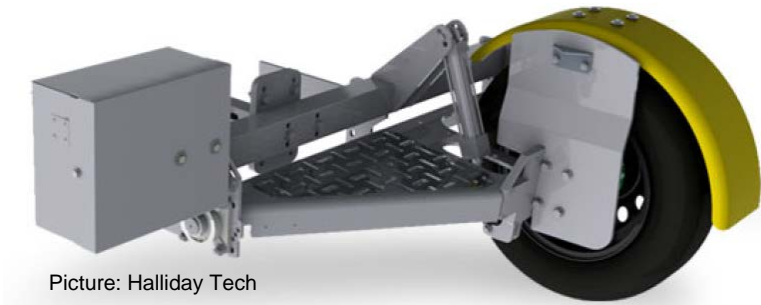
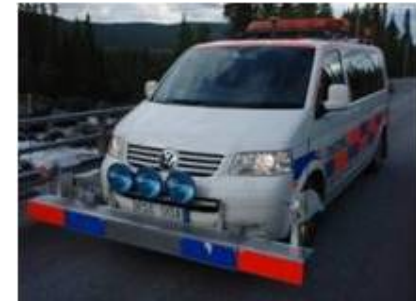
International Friction Index (2)

$$FS = F60 \times EXP ((60-S)/Sp), \text{ where}$$

F60 = Friction at 60 km/h

$$Sp = \text{Speed index} = 14.2 + 89.7 \times \text{MPD}$$

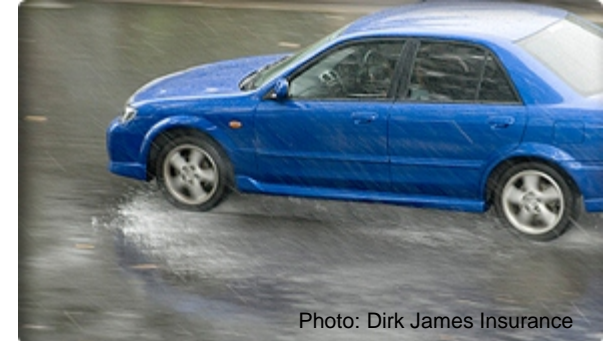
Dynamic hydroplaning:

A thick waterfilm can give the tyre a lift already at low speed.

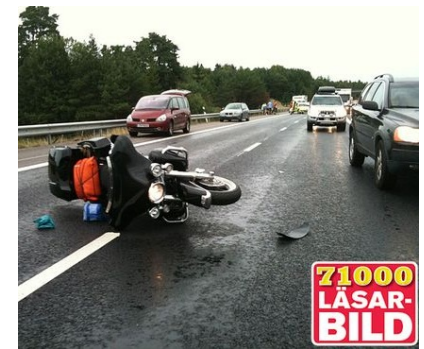
Viscous hydroplaning:

May occur already at 0.5 mm waterfilm (barely moisted surface).
Wheel locks easily, without transferring significant braking forces.

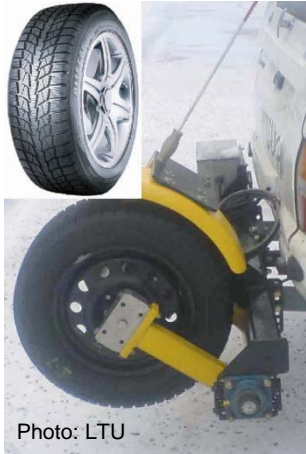
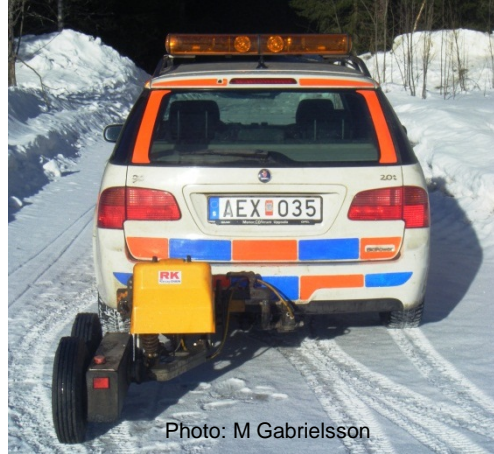
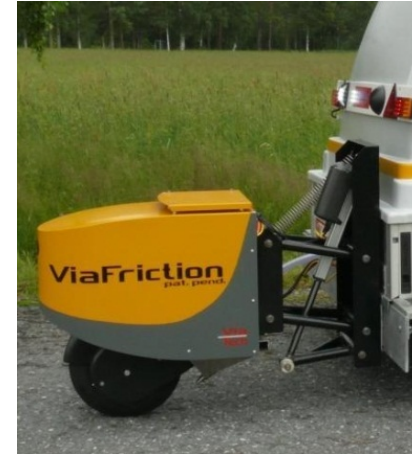
Sweco use several types of friction meters:

- **RT3** measures with normal car tyres and 1.5° drift angle. *Measures surfaces ranging from dry asphalt to polished wet ice.*

- **TWO** measures with industrial forklift tyres, made of very hard rubber, rotating with 20 % longitudinal slip. *Delivers minimal variance between repeated measurements.*
- **ViaFriction** has a water spraying system and measures at variable slip and at any speed. *Measured data are normalized to 18 % slip at 60 km/h; perfect for accurate calculation of International Friction Index (IFI) and other friction indices.*

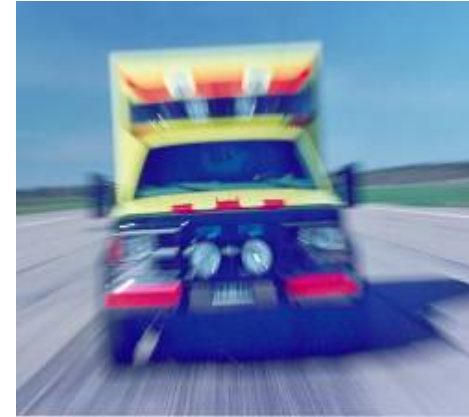
Roughness shape

Vertical motion in vehicle at speed

Elevation, depth, height [mm]

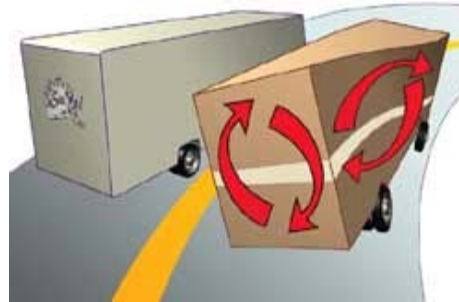
Road unevenness cause **poor road grip**

Weight transfer:

Road roughness (as well as wind bursts, acceleration, braking and cornering) cause weight transfer from side to side.

Weight transfer reduce the vehicle's total road grip and may cause skidding.

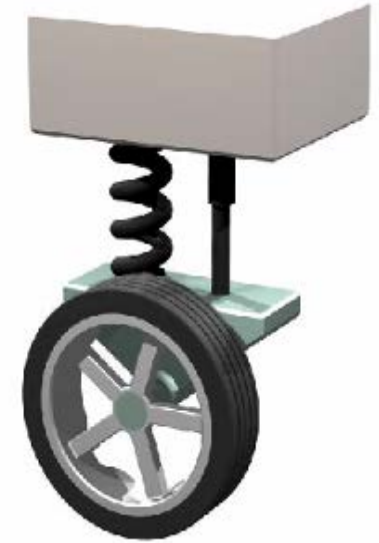
Figure 11. View of Highway Washboard Test Car of the Engineering Experiment Station, Car Is Shown with High Pressure Tires.

1927: Bump slope [mm/m] recorded by suspension stroke [mm/m].

1986: International Roughness Index (IRI) standardized by the World Bank.

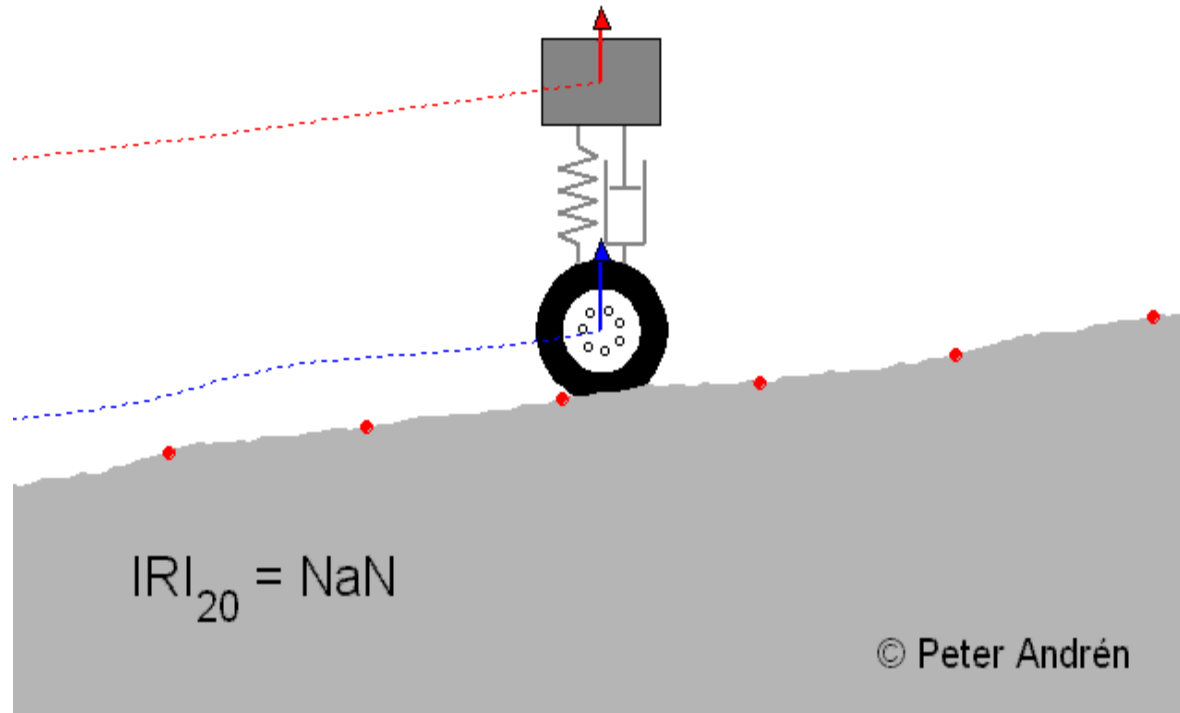
International Roughness Index

IRI = 0.784

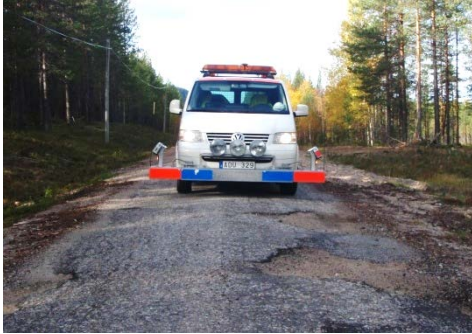
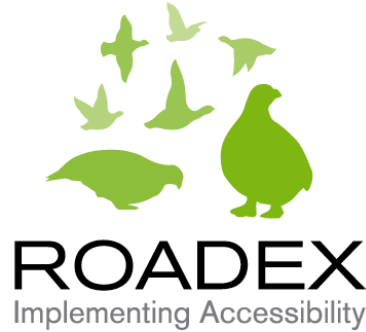
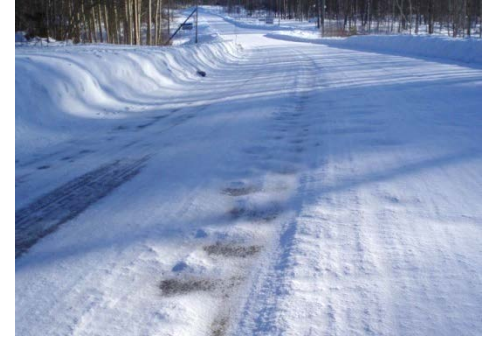
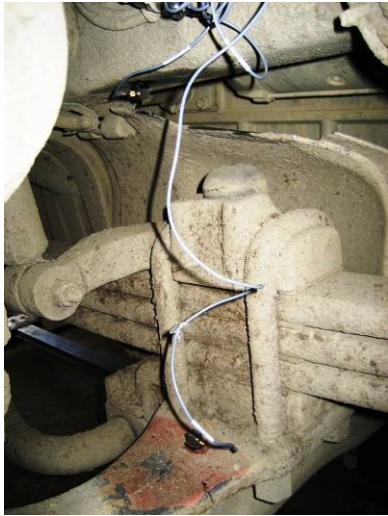
Mapping ride vibration from road profile to driver seat

Road properties are more decisive to drivers daily vibration exposure than vehicle suspension, speed and driving hours.

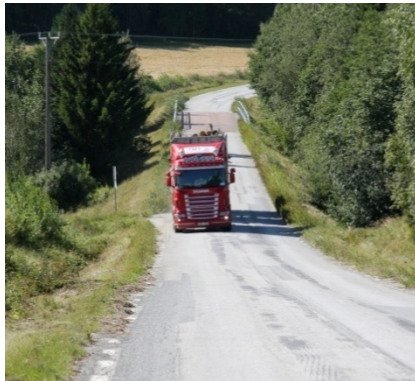
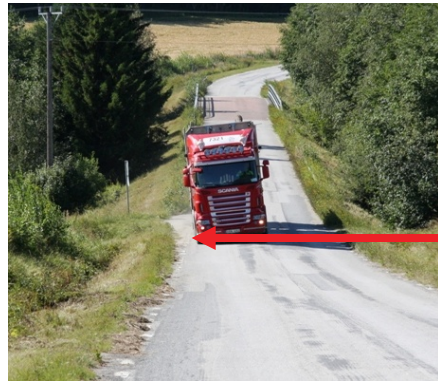
Hazardous edge slump

Deformed road edges cause roll vibration and roll-related lateral buffeting = skid risk on icy roads.

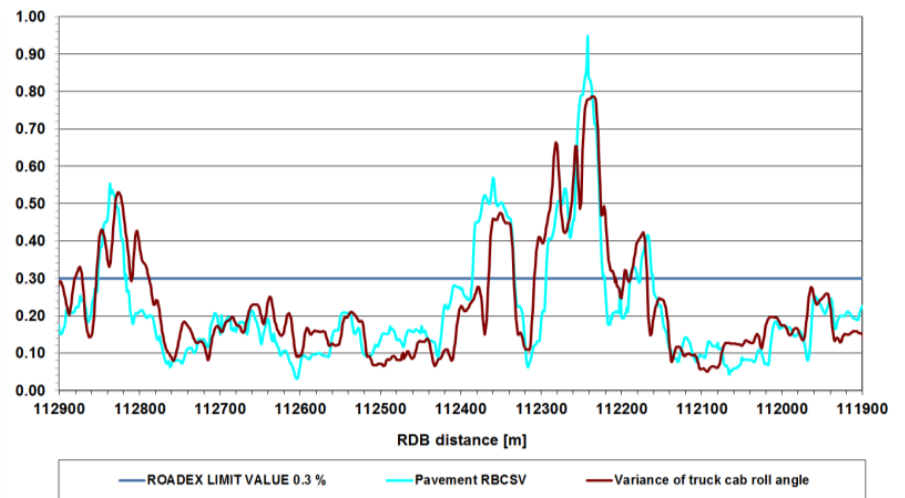
Edge slump is measured with the Rut Bottom Cross Slope Variance (RBCSV) parameter.

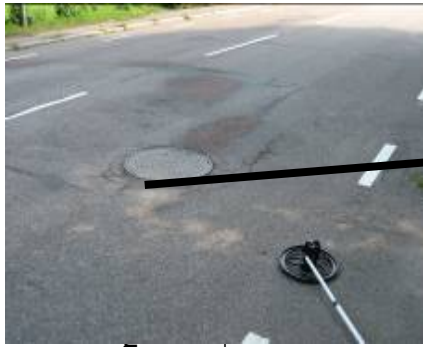
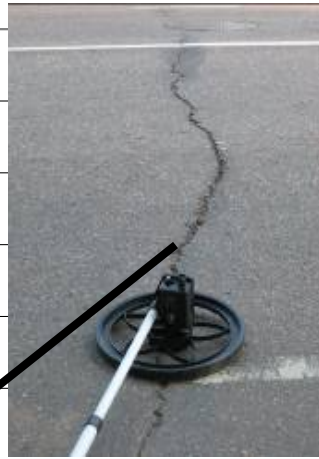
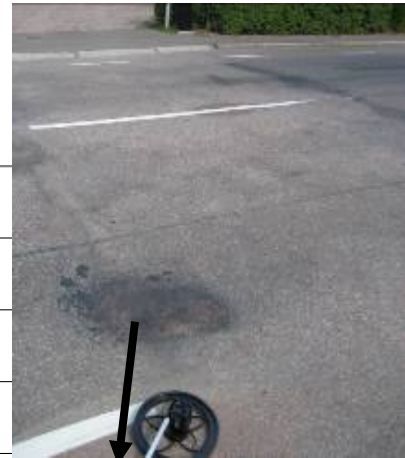
Megatexture are short wave **road damages**

Mjälgåvågen
Megatextur, medelvärde över 1 m

◆ Vänster spår
 ■ Mellan hjulspåren
 ▲ Höger spår

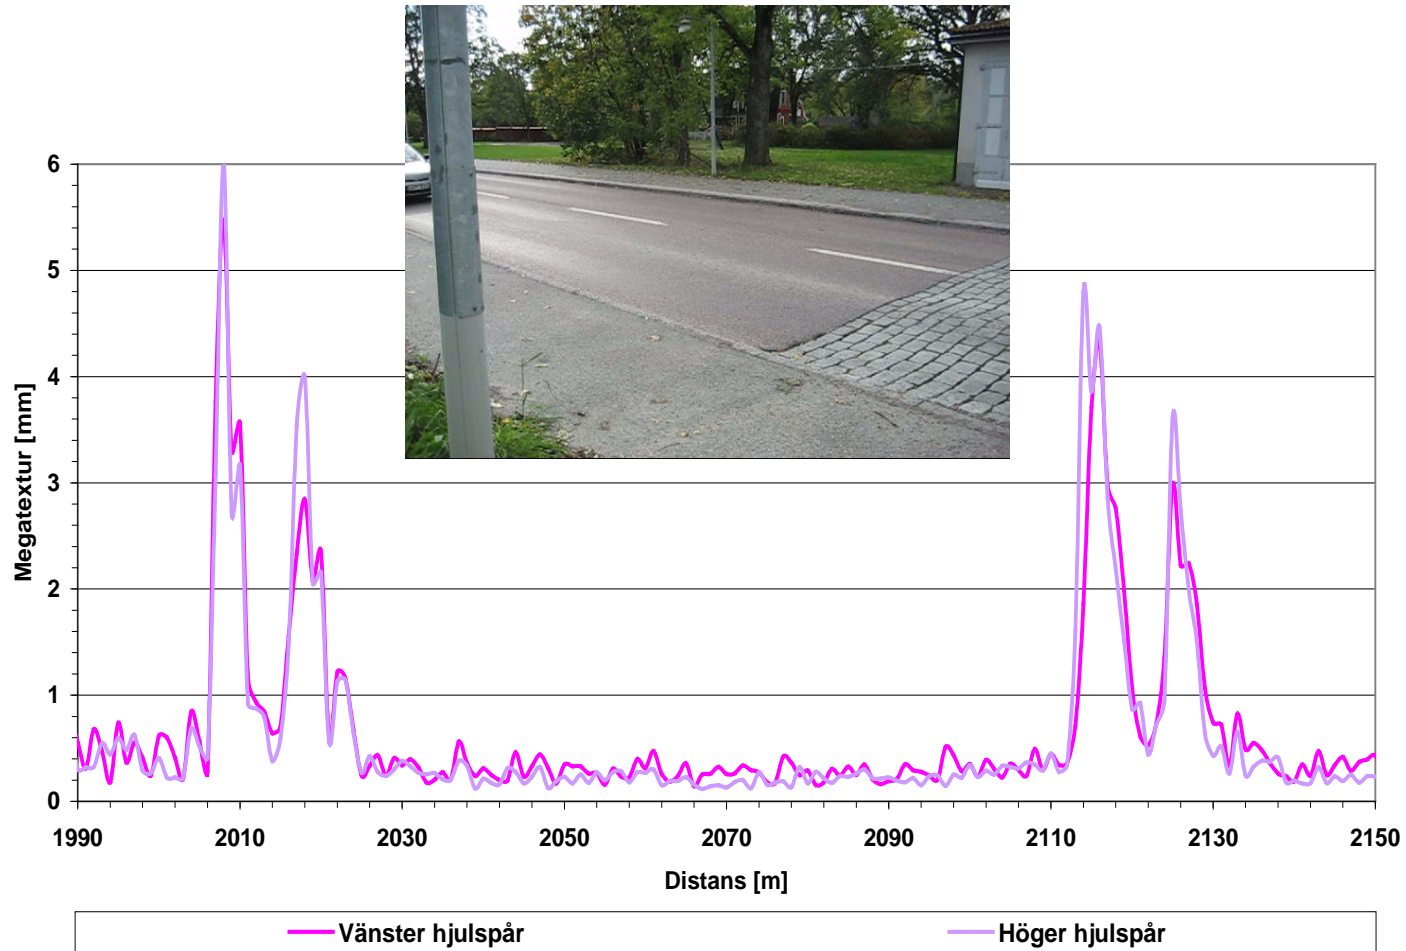
Noisy cobble stones

has much Megatexture

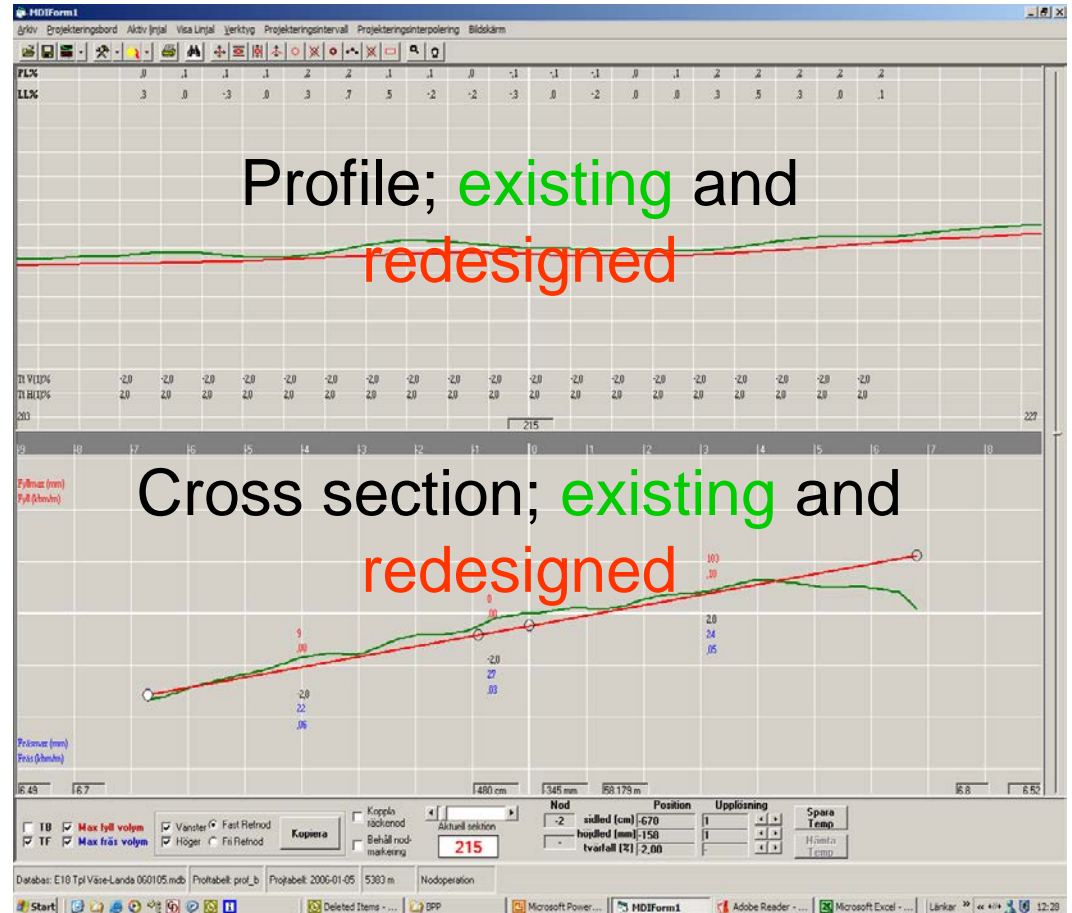
E18 Väse – Landa:
Computer Aided Design
(CAD) of **unevenness
repair**.

Spot levelling and milling,
followed by reinforcement
by 60 mm bound base.
On top: A thin wearing
course with high
resistance to wear from
studded tyres.
