FIELD STUDY OF INSULATED RAIL JOINT DEGRADATION ON VÄSTKUSTBANAN

Field study

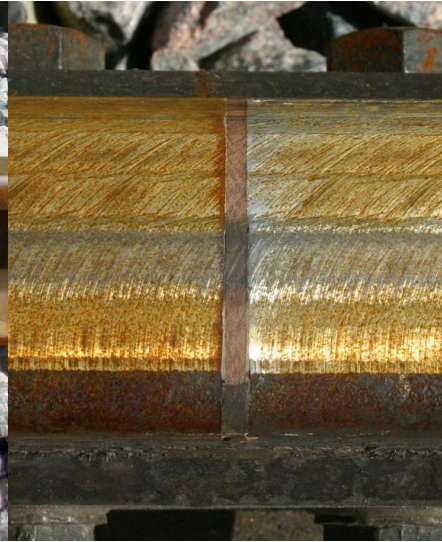
6-hole prefabricated insulated joint

*2008-06-11 (the week before
the start of operational traffic,
but after grinding)*

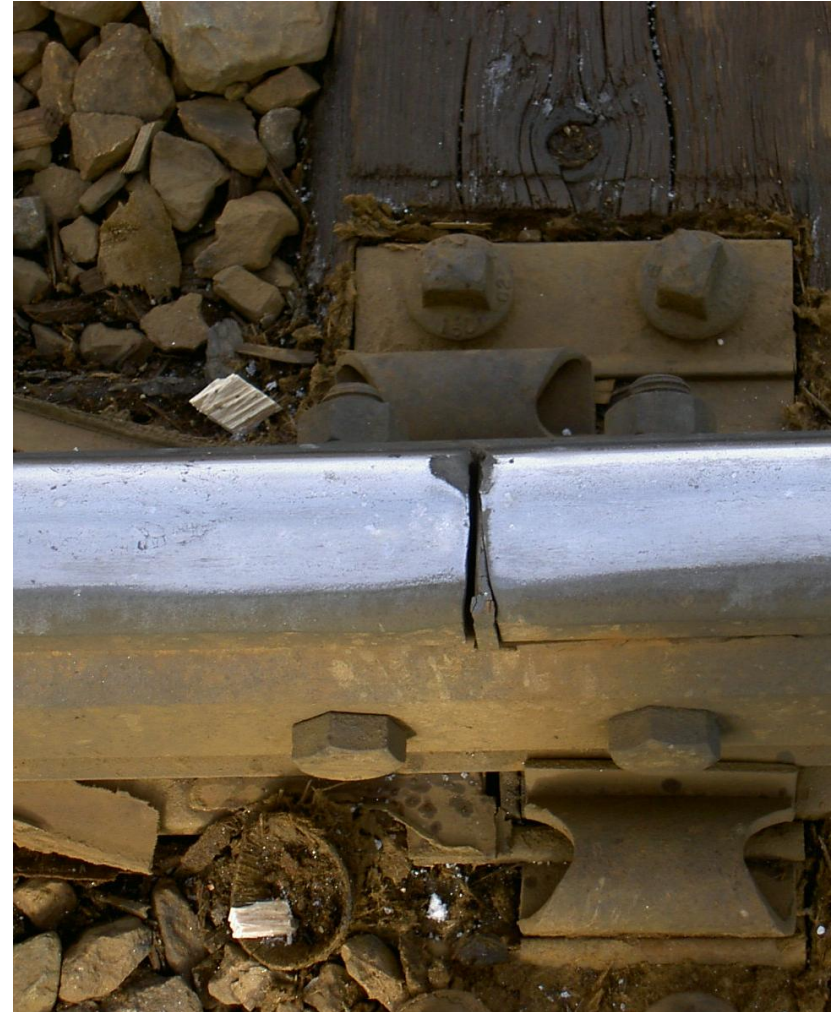
Deterioration of insulated joints

- The contact between the wheel and joint end causes stress magnitudes far above the yield limit of the rail steel
- As a result, plastic strain and fatigue damage accumulates in the material and causes roll-out and material failure
- One consequence is that metallic material starts bridging the gap, forming a conductive bridge
- Troublesome traffic disturbances are experienced when the joint gets short-circuited
- Other consequences are cracking of the joint and joint dipping

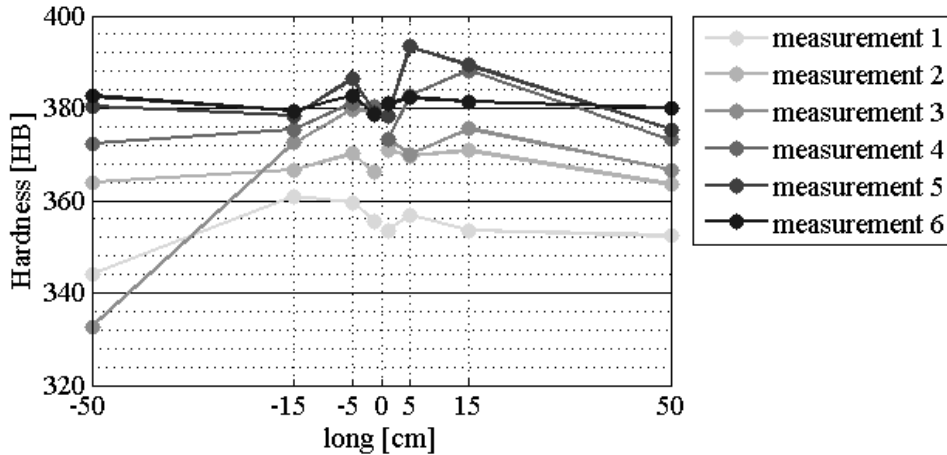
- Performed at the rail head surface close to the joint
- The joints manufactured from head hardened steel
- Hardness seems to have stabilized at the end of the observation period

Hardness averaged for the three lines closest to the rail head centre ("c", "d" and "e") for all joints at all six measurements
