Type of failure modes	
•	Rutting	
	<ul> <li>Depressions (Permanent deformation)</li> </ul>	
	- Studded tyre wear	
•	Cracking	
	Longitudinal     Fatigue cracking	
	Failure clacking     Single crack in the wheel path	
	- Alligator cracking	
	Seasonal (frost heave) cracks     Joint construction cracking	
	Edge (verge) cracking	
	<ul> <li>Transversal (thermal) cracking</li> </ul>	
	- Pattern cracks	
	Block Cracking     Joint Reflection Cracking	
•	Potholes	
•	Bleeding	
	Ravelling	
•	Stripping	
	Corrugation and shoving	
	Segregation	
	Patching	
	5	
	Polishing	
•	Depressions	
•	Slippage cracking Water bleeding and pumping

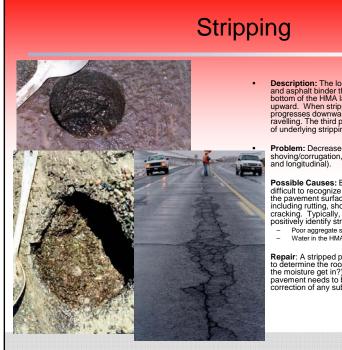
**Description:** The loss of bond between aggregates and asphalt binder that typically begins at the bottom of the HMA layer and progresses upward. When stripping begins at the surface and progresses downward it is usually called ravelling. The third photo show the surface effects of underlying stripping.

Problem: Decreased structural support, rutting, shoving/corrugation, ravelling, or cracking (alligator and longitudinal).

Possible Causes: Bottom-up stripping is very difficult to recognize because it manifests itself on the pavement surface as other forms of distress including rutting, shoving/corrugations, ravelling, or cracking. Typically, a core must be taken to positively identify stripping as a pavement distress. – Poor aggregate surface chemistry. – Water in the HMA causing moisture damage

Repair: A stripped pavement should be investigated to determine the root cause of failure (i.e., how did the moisture get in?). Generally, the stripped pavement needs to be removed and replaced after correction of any subsurface drainage issues.
